SAFETY ALERT

Hangar Operations

Fuel and Electricity

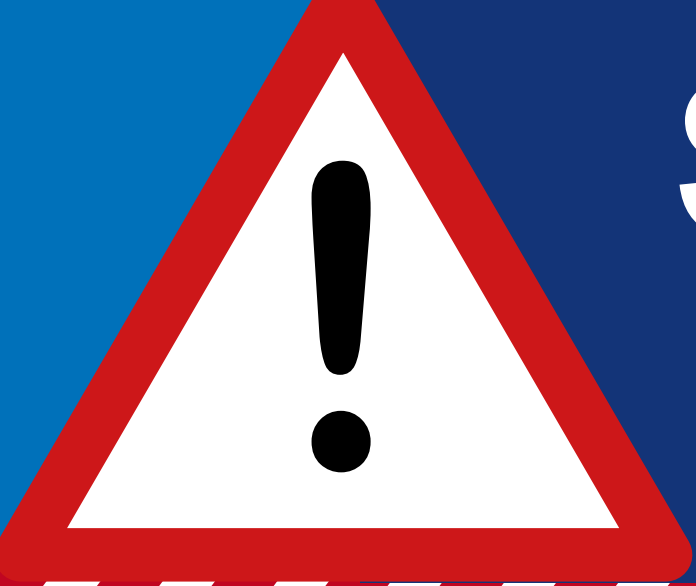
Recently during a routine visit to the hanger, a smell of fuel was detected. Upon further examination fluid was observed behind the nose wheel of a light aircraft.

Additionally a live extension cable with a battery charger plugged in was located approximately 4cm from the fluid. Posing a potential fire risk.

It transpired that the last person to fly this aircraft was unaware that if a valve is not closed on this particular aircraft type, fuel can build up in the carburetor.

The cable was disconnected and the owner contacted.

Please consider where you locate electrical appliances in a hanger which may have a damp or wet floor and possible fuel leaks.
